Windscreen Repair – Technical

TEST AND EXAMINATION OF THE PERFORMANCE OF AUTOMOTIVE LAMINATED WINDSCREEN REPAIR SYSTEMS

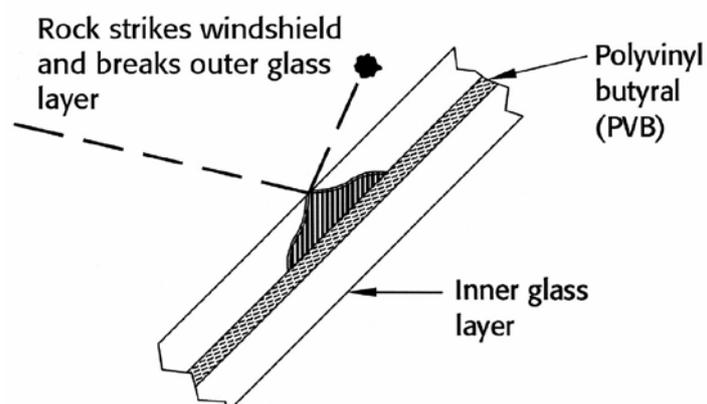
Cracks can extend from the break, as is characteristic of a star break or a combination break. Those cracks are visible due to the difference in the refractive index between the air and the glass. In addition, there may be small, loose glass fragments at the impact point.
